# **Exhibit 13**

# Building Forensic Survey

Mr. Hubert & Karen Jasinski  
190 Wrentfield Way  
Harleysville, PA 19438

*Report Prepared by an Authorized Exterior Design Institute & MoistureFindIR™ Contractor*  
The Green Valley Group, Thermal Imaging and Building Forensic Services  
484-880-3208 [kevin@thegreenvalleygroup.com](mailto:kevin@thegreenvalleygroup.com)

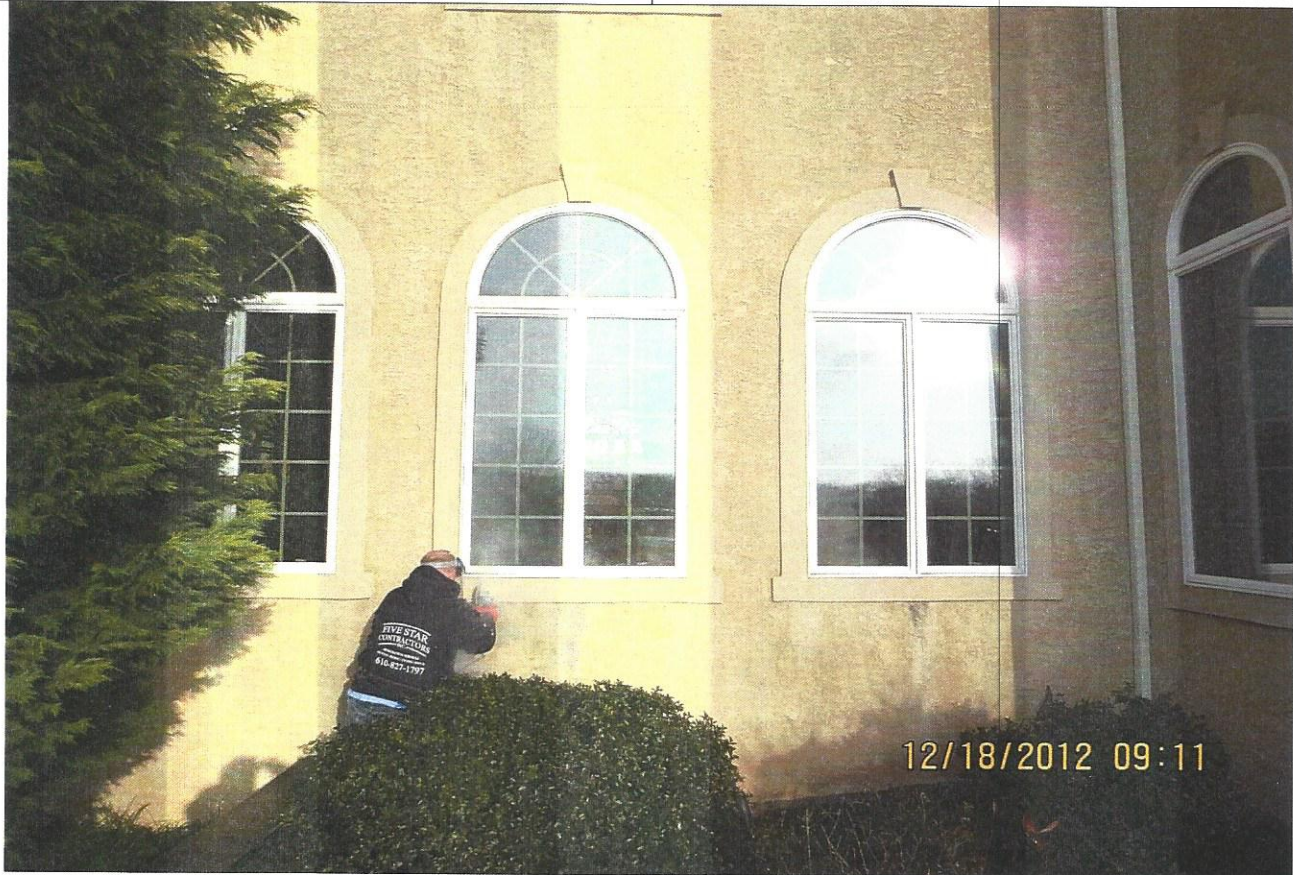
**LOCATION:** Exterior**WHERE:** Front Wall

The center window on the left side of the home was subject to destructive testing following a building moisture survey that revealed elevated moisture levels in the homes Oriented Strand Board (OSB) sheathing. The cause source of the water intrusion needed to be located in order to piece together an adequate remediation plan.

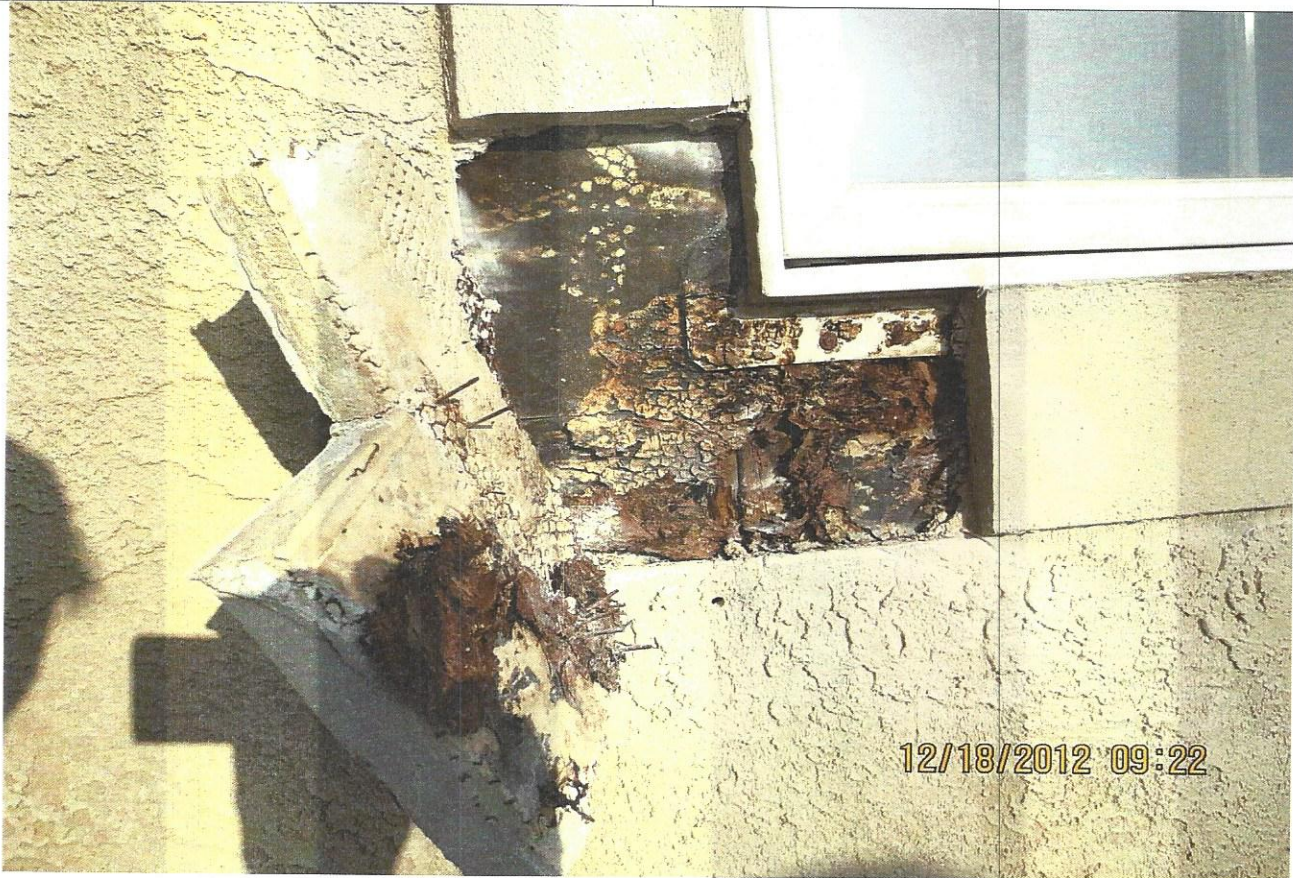
**WHERE:** Front center left window.

Upon removing the stucco, severe sheathing and framing decay were noted. The weather resistant sheathing paper used during construction was not properly lapped under the bottom window nailing flange. This in combination with protruding stucco band and inadequately terminated or sealed stucco to the windows led to prolonged water penetration to the walls of this home.

**RECOMMENDATION:** Remove all of the stucco from the home in order to properly remediate any rot, decay or microbial growth and correct the construction deficiencies.

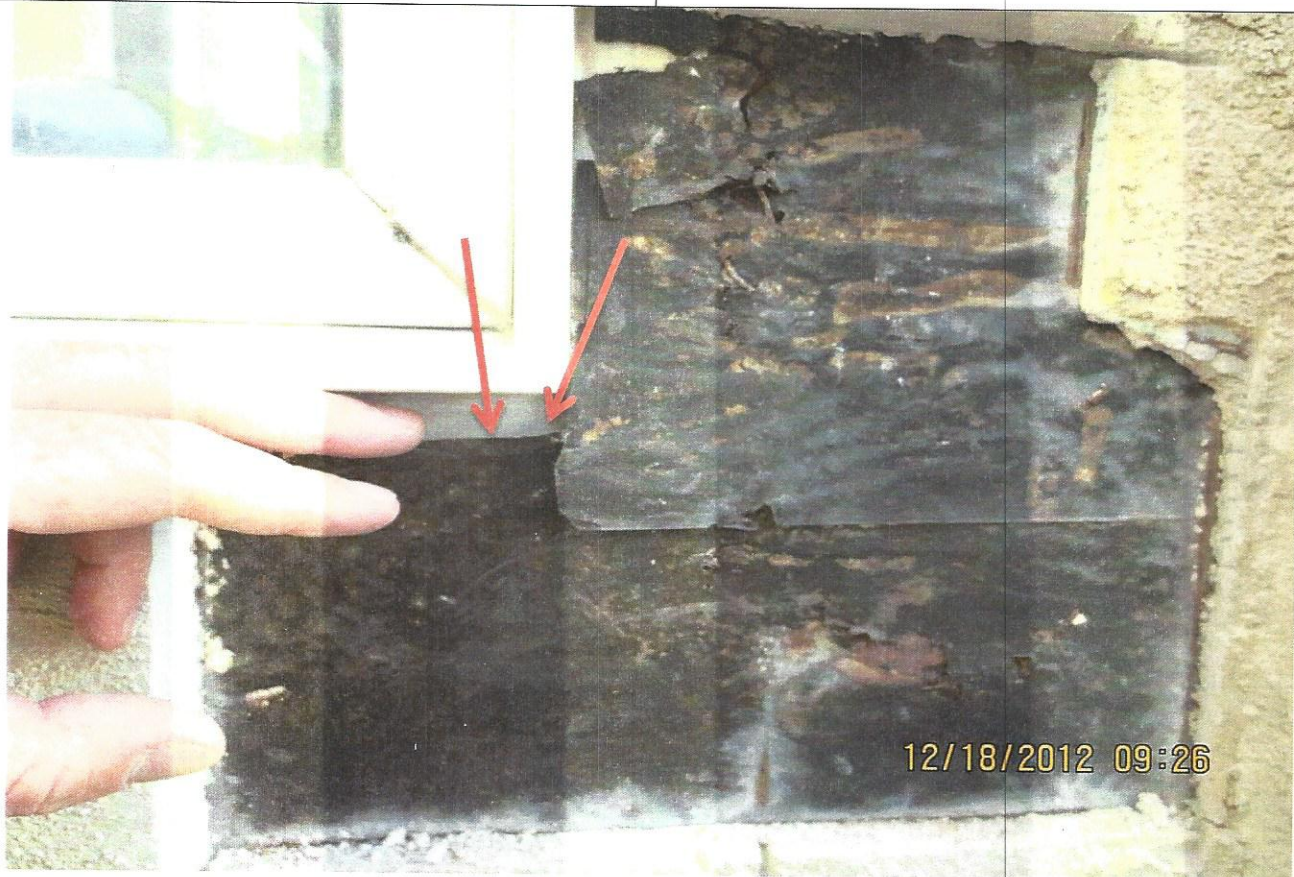
**WHERE:** Front, left, inside corner window.

Due to the extreme decay of the weather resistant sheathing paper on the first window opened, another window with less decay was opened in order to document the inadequate lapping at the bottom nailing flange. With the paper lapped over the bottom nailing flange it provides a void in a very vulnerable area in which water is able to enter behind the paper and reach the wood sheathing and framing of the home.

**RECOMMENDATION:** Remove all of the stucco from the home in order to properly remediate any rot, decay or microbial growth and correct the construction deficiencies.

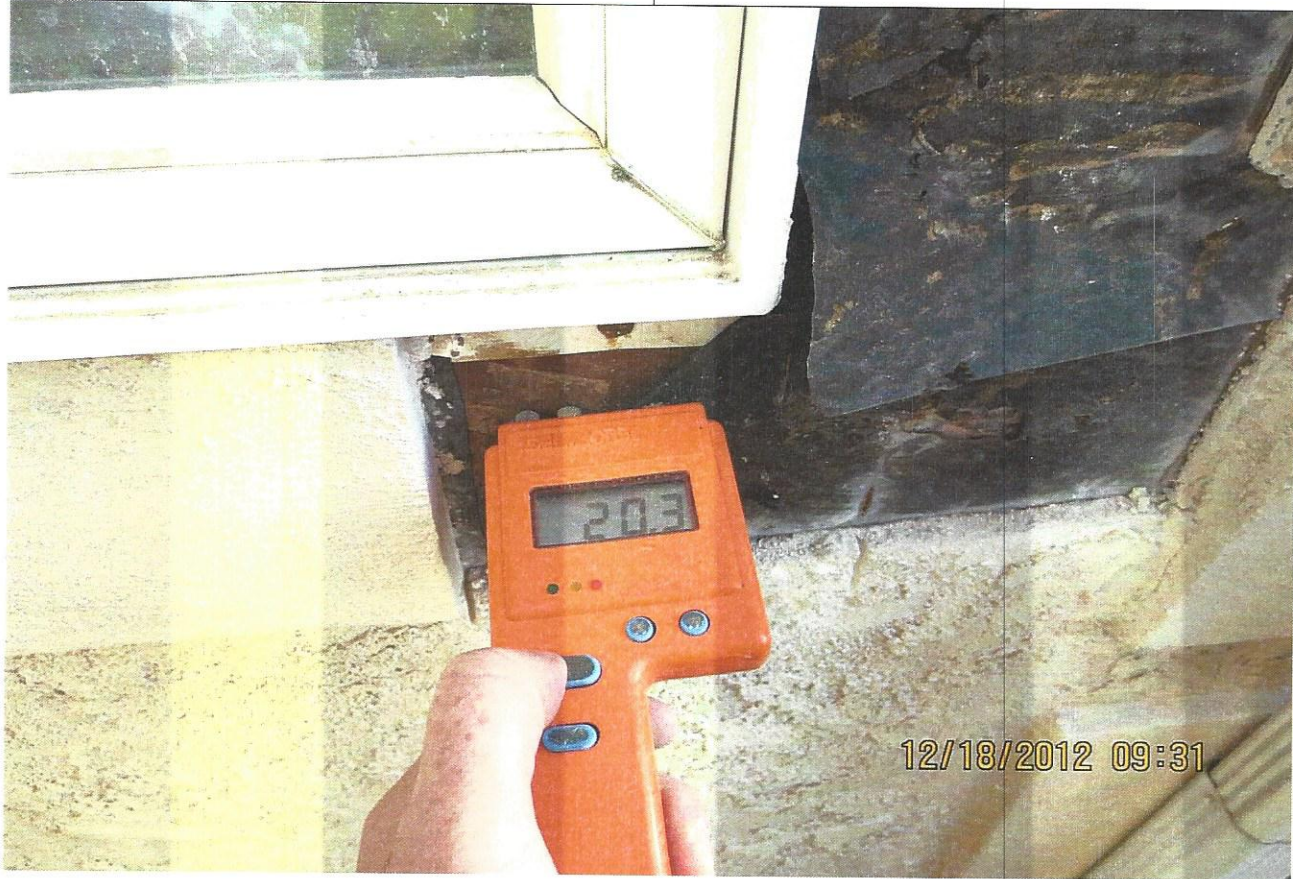
**WHERE:** Front, left, inside corner window.

The second window opened was not as decayed as the first, however elevated moisture levels did exist in the sheathing.

**RECOMMENDATION:** Remove all of the stucco from the home in order to properly remediate any rot, decay or microbial growth and correct the construction deficiencies.

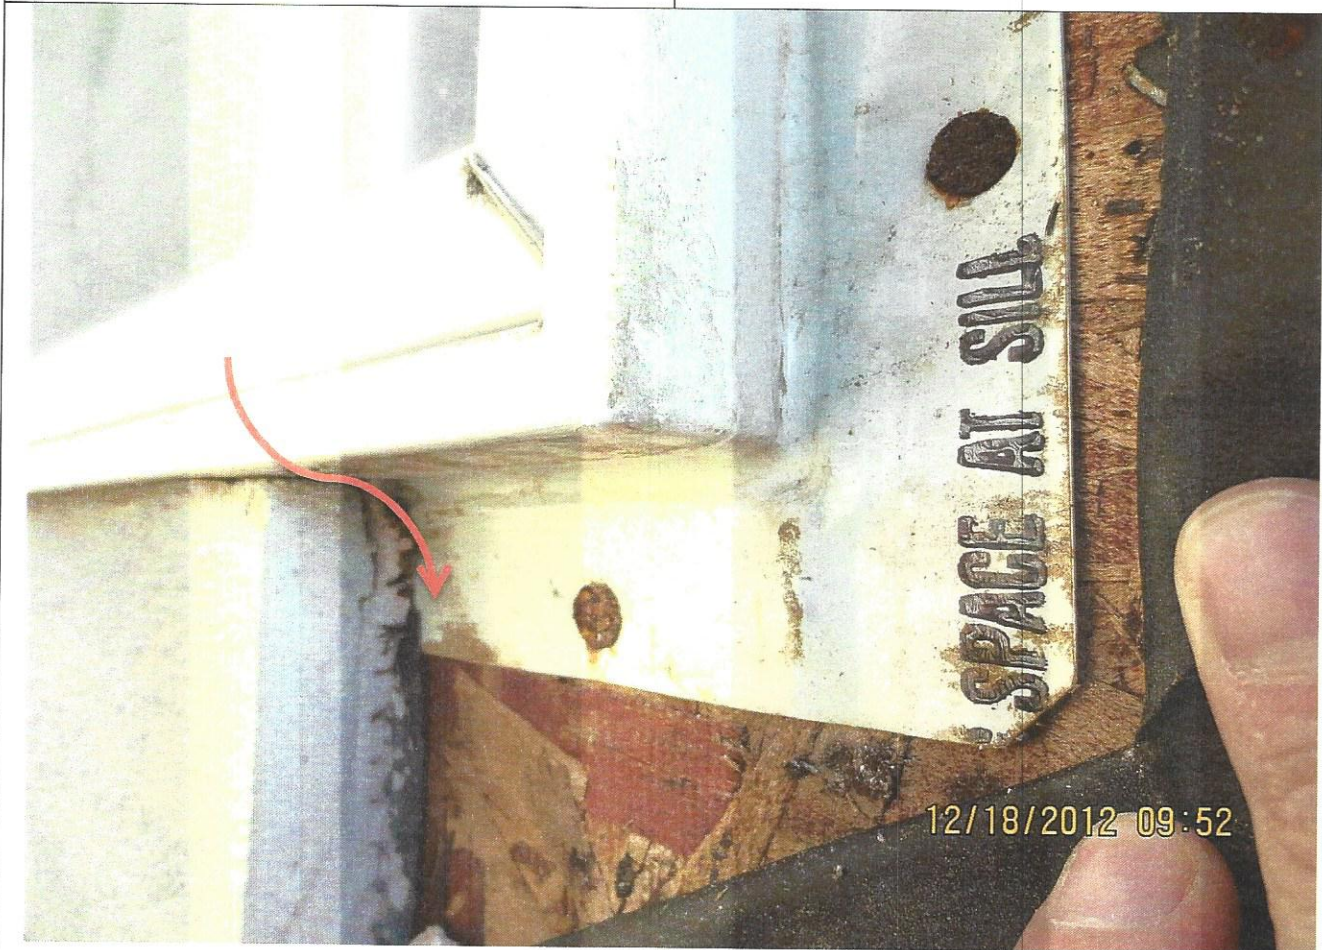
**WHERE:** Front, left, inside corner window.

The stucco was not adequately terminated or sealed around the windows. By not providing space for expansion stresses premature cracking and window failure can occur. By also not providing space to accept backer rod and caulk, water was able to wick through these openings and enter the wall cavity through the space provided by the incorrect lapping of the water resistant sheathing paper over the windows bottom nailing flange.

**RECOMMENDATION:** We recommend further review of this area and repair as needed.

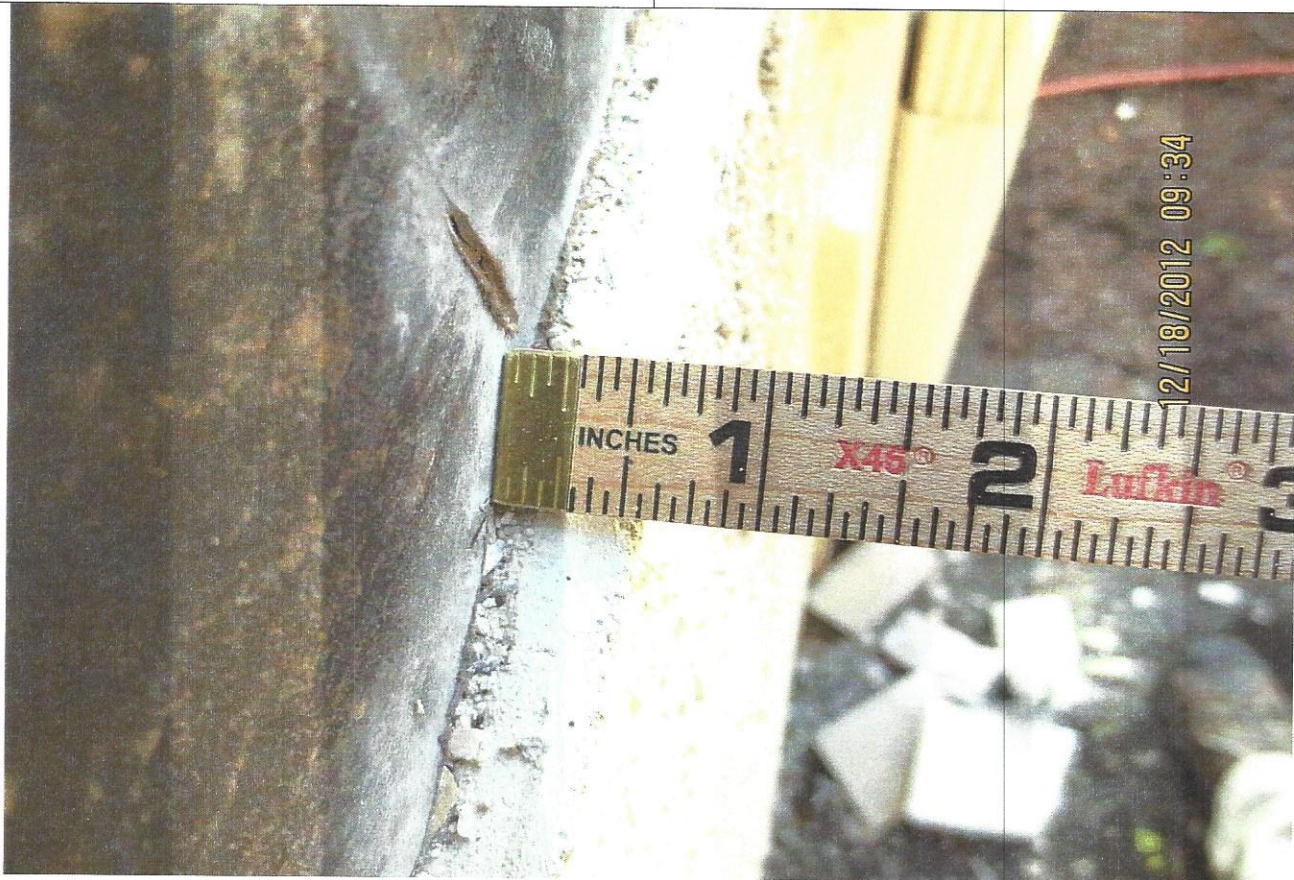
**LOCATION:** Exterior**WHERE:** Stucco

The stucco was not applied to the thickness specifications of the 1995 CABO code or ASTM C926. The stucco appears to be a two coat system with an average thickness of 1/2" to 5/8" thick. The required installation is three coats with an average thickness of 7/8".

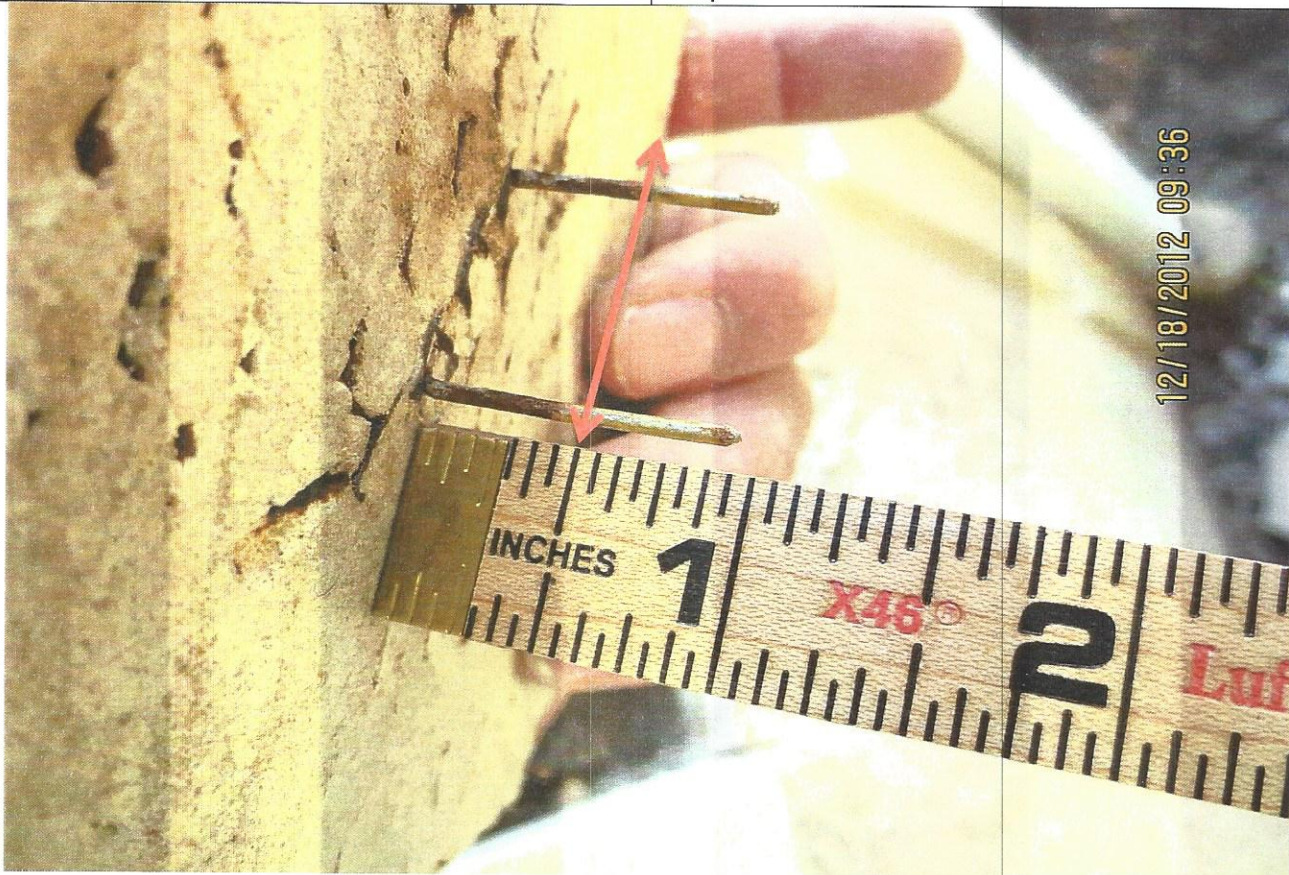
**WHERE:** Stucco wire lath attachment staple.

One inch staples were used in order to attach the wire lath to the structure that supports the stucco. The fasteners are required to penetrate into the framing members by a minimum of 3/4 of an inch. The one inch staples used after passing through the sheathing would have a maximum penetration depth in to the sheathing of 1/2 of an inch. This does not meet the required penetration depth for adequate hold strength to support the stucco. The staples were also placed in a haphazard pattern that many missed the framing members entirely.

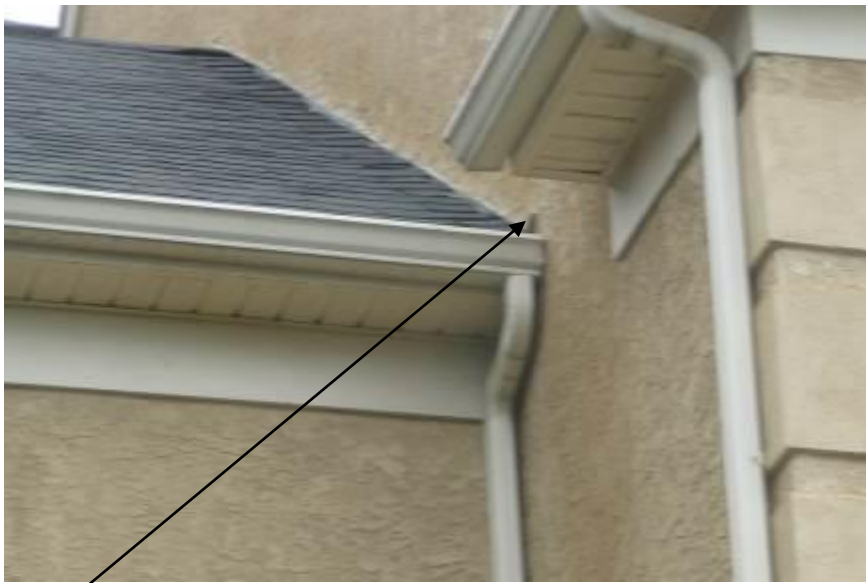
**kick outs...**

**small, but functioning**

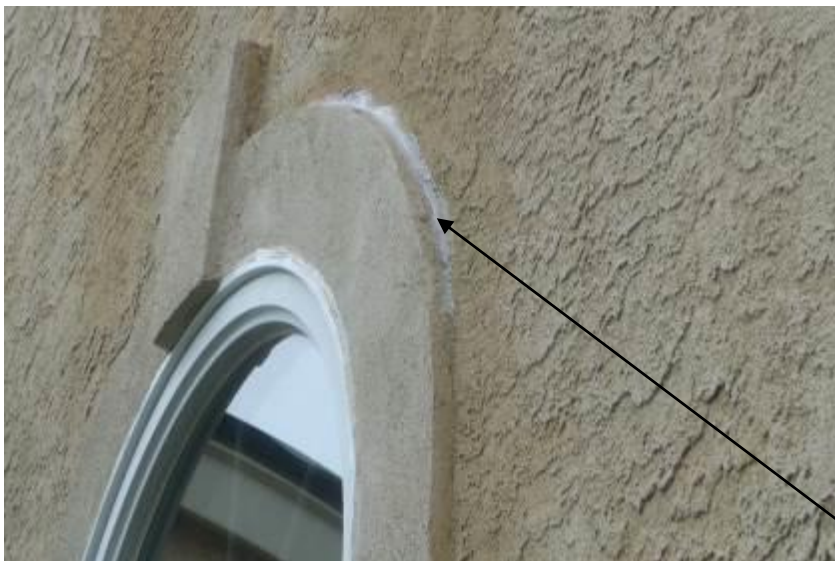
**around too thick stucco trim details.**

**caulk trying to seal gaps**

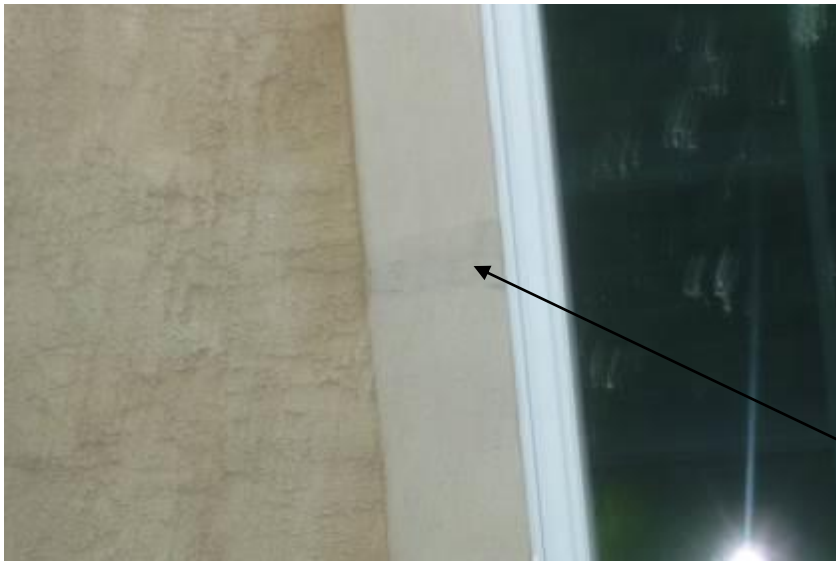
buckling stucco raised

surrounds, due to thickness and the lack of stop beads and sealant..

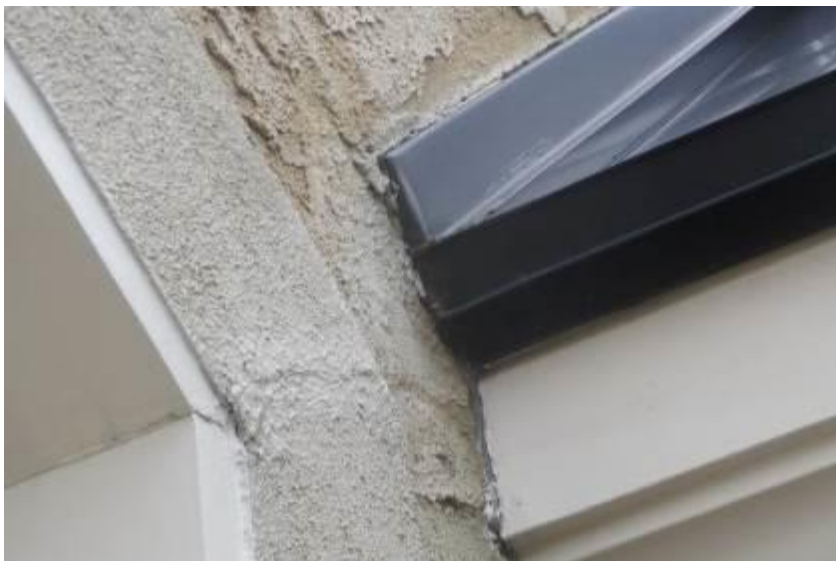
no kick out flashing next to

windows at metal roofs, .

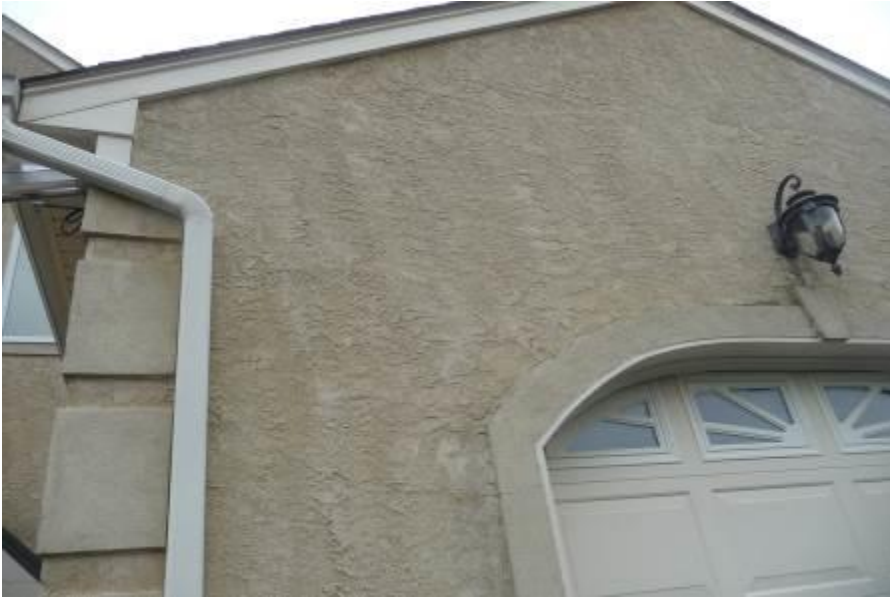
the only moisture readings below the carriage lamp assembly and to the sides of the raised stucco detail.

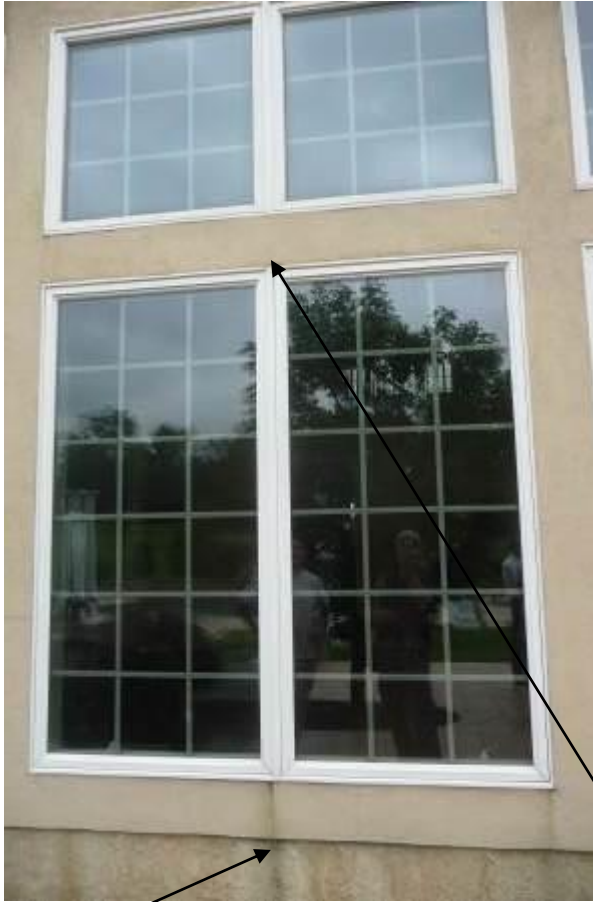
and wet readings below.

no head flashings between mulled sash, stains

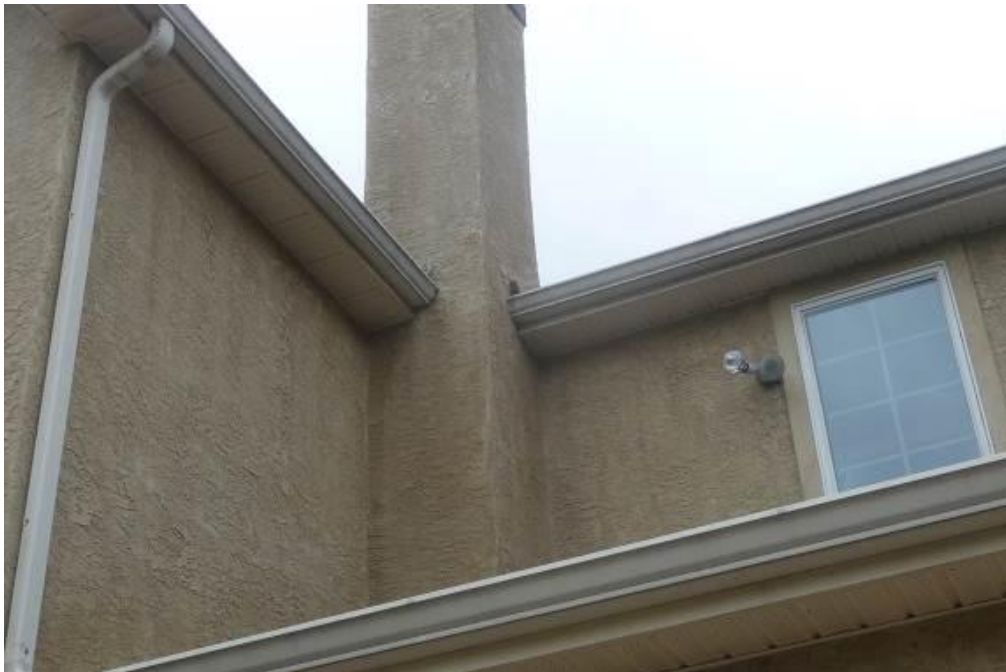
functioning kick outs...

small but

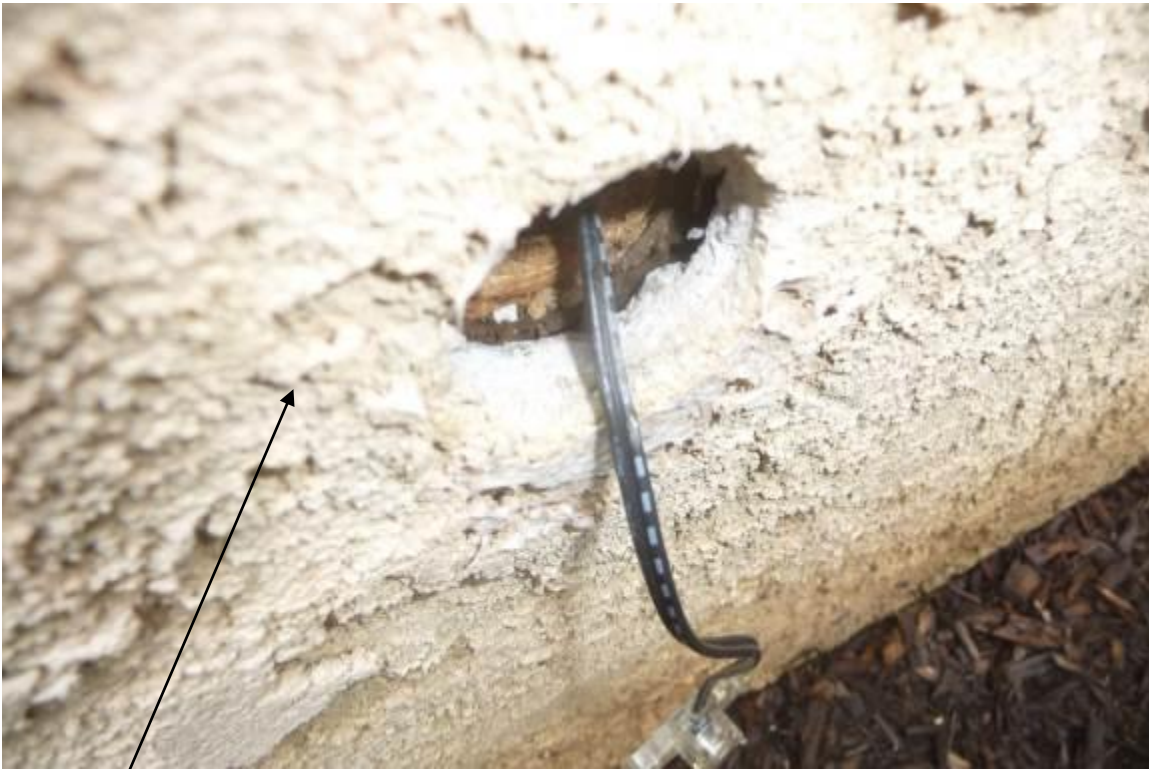
owner created hole in the front, showing thickness, one layer asphalt house wrap, but no wet readings,...
